**BOARD OF COUNTY COMMISSIONERS  
ESCAMBIA COUNTY, FLORIDA**

**NOTICE OF SHOW CAUSE HEARING/PUBLIC HEARING**

Case Number: COM140900031

Location of Complaint: 525 W LEE

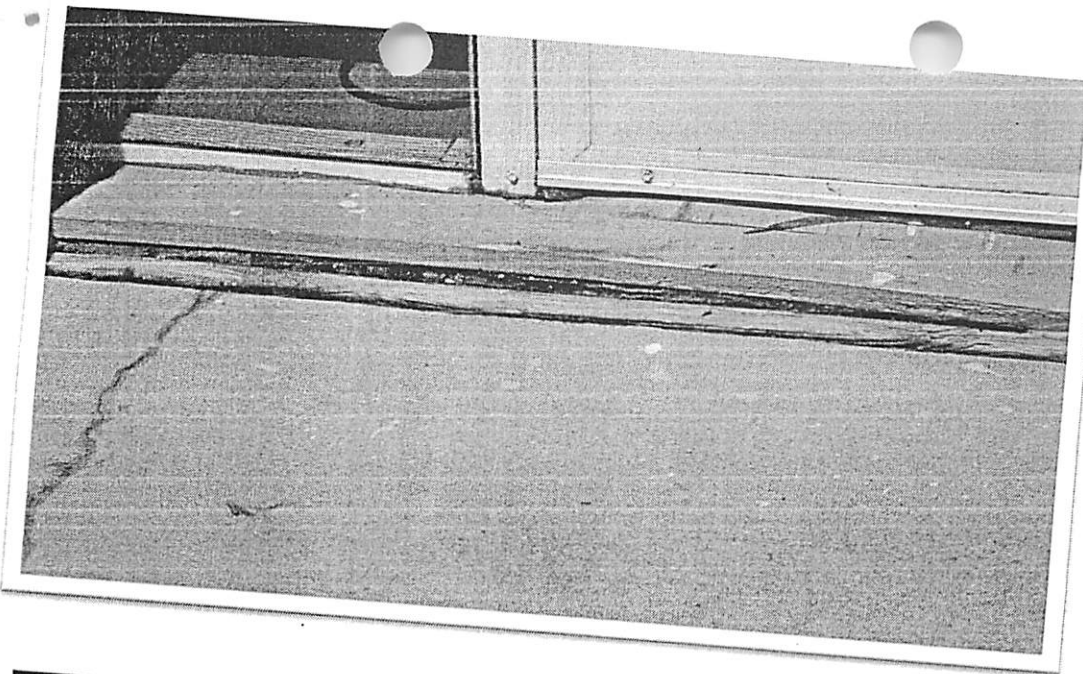
Photo above shows edge of added pt plywood sheet ending at first joist off exterior wall (wall is same as foundation in this case)

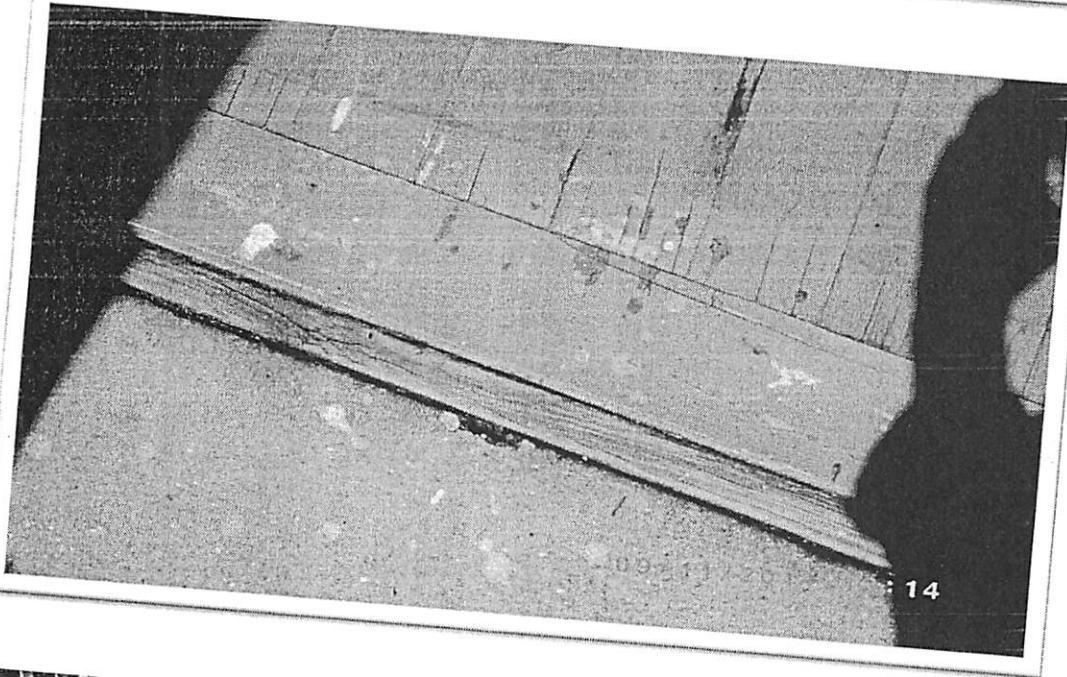
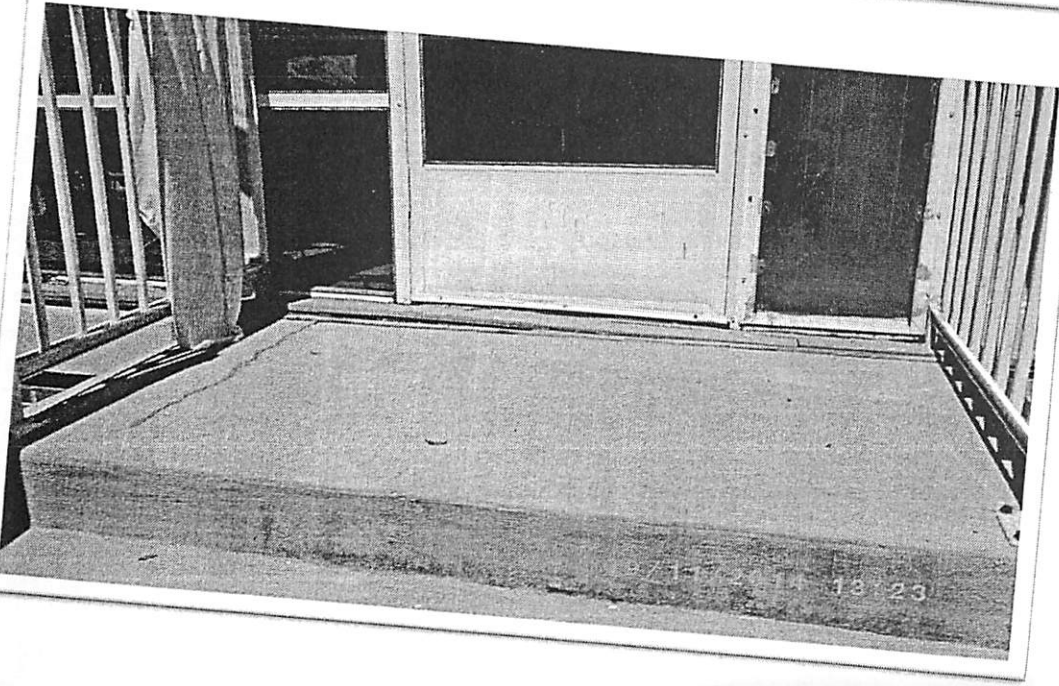
Due to the water the wood also began warping causing further splitting. The way the patio flooring was laid caused water to run toward the house, rather than running off the porch outside. On 9/7/14 it was discovered that the wood was now rotting, evidently from water damage due to building practices.

3 photos show how the pt ply has expanded with weather exposure, allowing water to begin splitting deck boards. Ply extends full width of deck and goes back into foundation supports about 24".

**09/11/2014** READ FORWARDED DOCUMENTATION. CALLED CITY OF PENSACOLA TO INSURE THAT NO PERMIT (OR PERMIT ADDITION) DENOTED THE BACK PORCH. SPOKE TO MR KING WHO SAYS THE THERE ARE TWO DISTINCTLY DIFFERENT PORCHES. MADE APPOINTMENT TO PHOTOGRAPH CONDITION. TOOK PHOTOS. MR NEAL'S INVOICES READS "REMOVED AND REPLACED THE FLOOR DECKING SYSTEM ON THE BACK PORCH". MUST ASK MR NEAL TO EXPLAIN WHAT EXACTLY THIS MEANS. UPON INSPECTION, THE BACK DECK IS SUPPORTED BY A FOUNDATION CONTINUOUS WITH THE ENTIRE HOUSE. SOME OF THE POST AND BEAM REPAIRS NOTED ON THE PERMIT INCLUDE AREAS UNDER THE BACK DECK. THE PROBLEM APPEARS TO BE A PIECE OF PT PLYWOOD, WHOSE EXPOSED EDGE HAS ALLOWED WATER TO PENETRATE INTO IT AND RAISE THE FLOOR BOARDS ATOP OF IT, TRAPPING WATER, AND SPLITTING TOP BOARDS.
